# Manhole Inspection Summary

Manhole # S43E\_\_017MH

Insp Date: **6/9/08 11:21 AM**

**Location** Address: **1520 e fairmount ave**

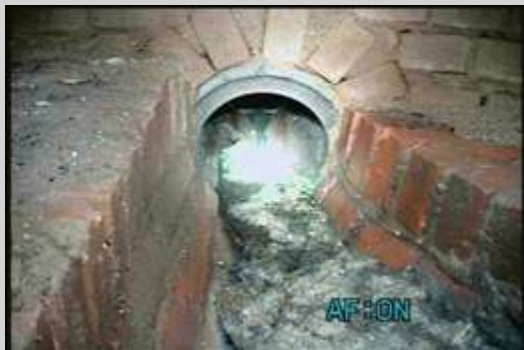
12 O'Clock Outflow

8 in. Circular Gravity Sewer  
Pipe Out @ 12 O'Clock

Invert Depth: 10.05 (ft.) Flow Characteristics: None

Infiltration: None Pipe Seal Cond: Unknown

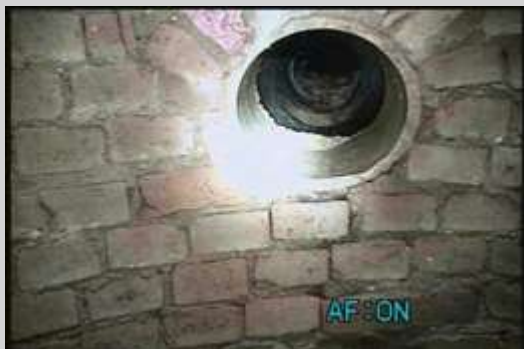
3 O'Clock Inflow

8 in. Circular Gravity Sewer  
Pipe In @ 3 O'Clock

Invert Depth: 8.49 (ft.) Flow Characteristics: None

Infiltration: None Pipe Seal Cond: Unknown

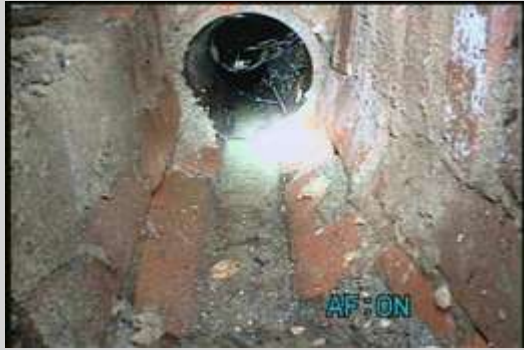
6 O'Clock Inflow

8 in. Circular Gravity Sewer

Pipe In @ 6 O'Clock

Infiltration: **None** Pipe Seal Cond: **Unknown**
